WATER QUALITY RESTORATION PLAN AND TOTAL MAXIMUM DAILY LOADS FOR THE SUN RIVER PLANNING AREA

DECEMBER, 2004

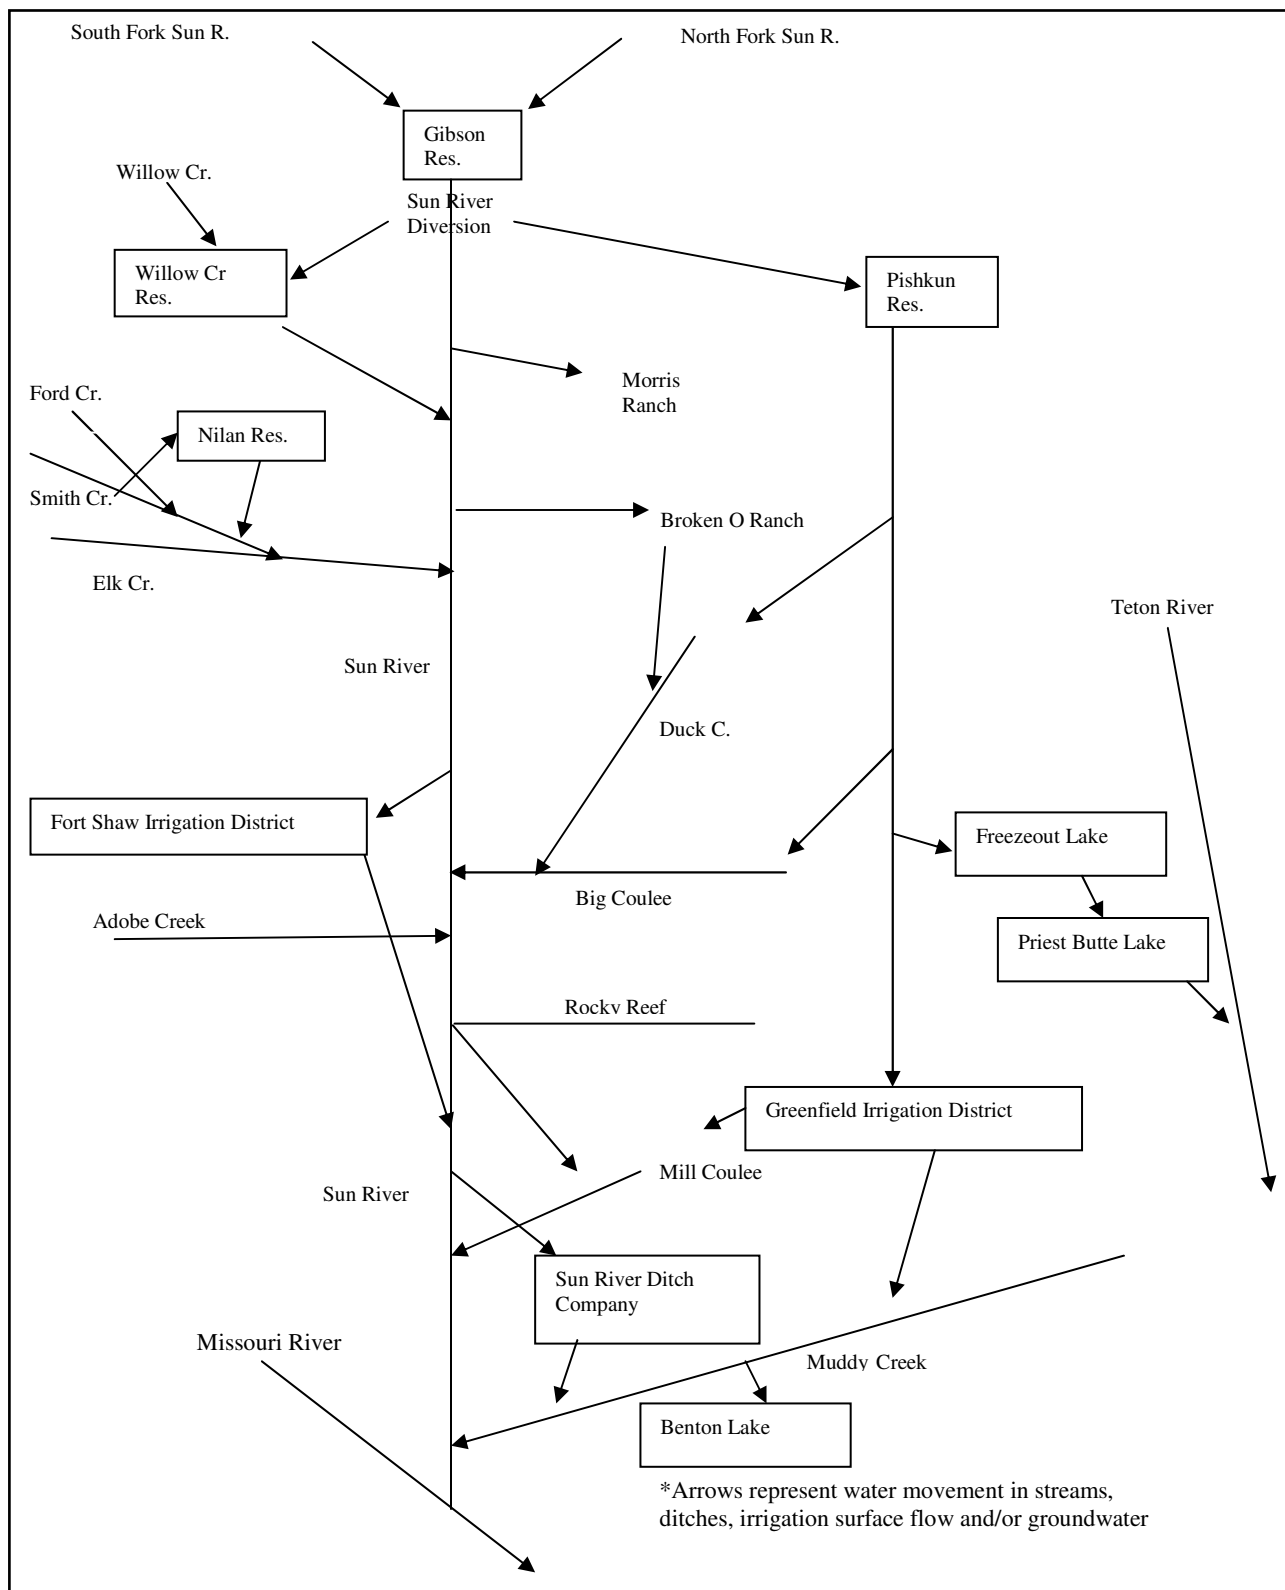
Figure 4-1. Diagram of Major Water Flow Paths for Water Use in the Sun River Watershed.

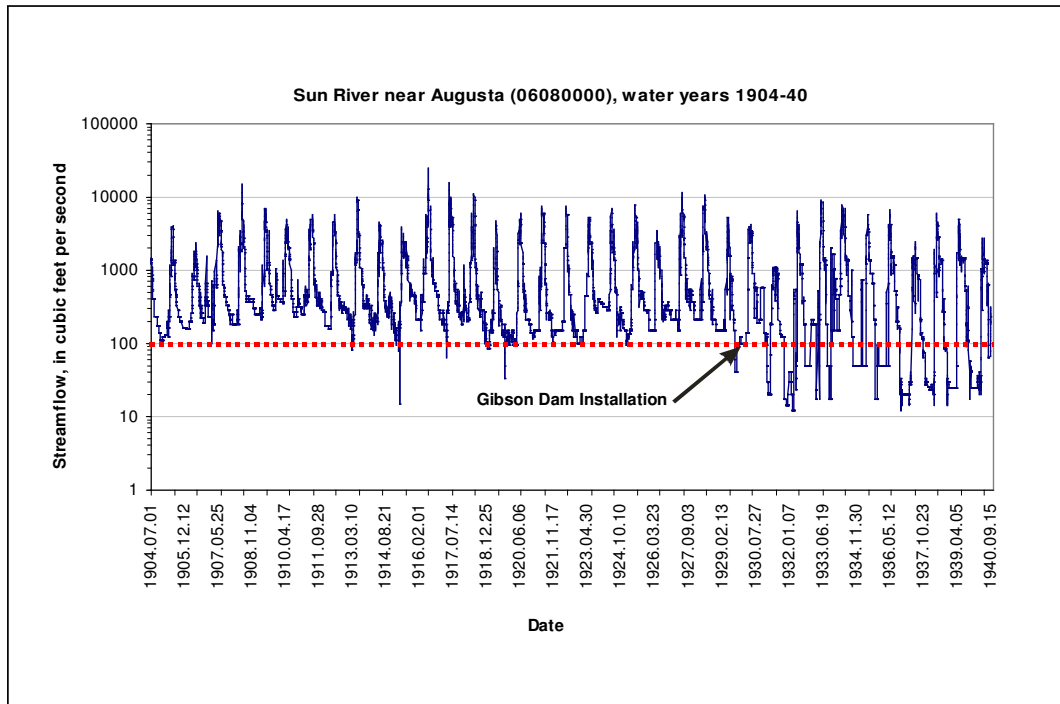
Figure 4-2. Hydrograph Illustrating the Effect of the Gibson Dam Installation in 1929 on Stream Flow Conditions in the Sun River.

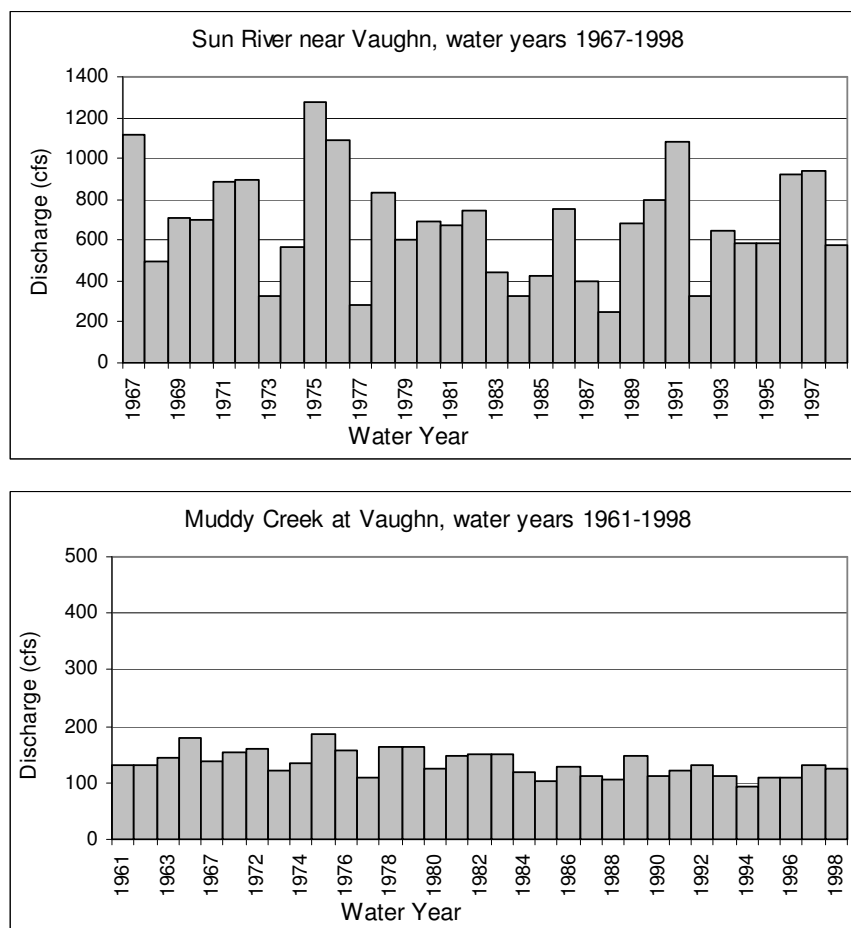
Figure 4-4. Annual Mean Stream Flow at the Sun River Near Vaughn and Muddy Creek at Vaughn Stations in the Sun River Watershed.

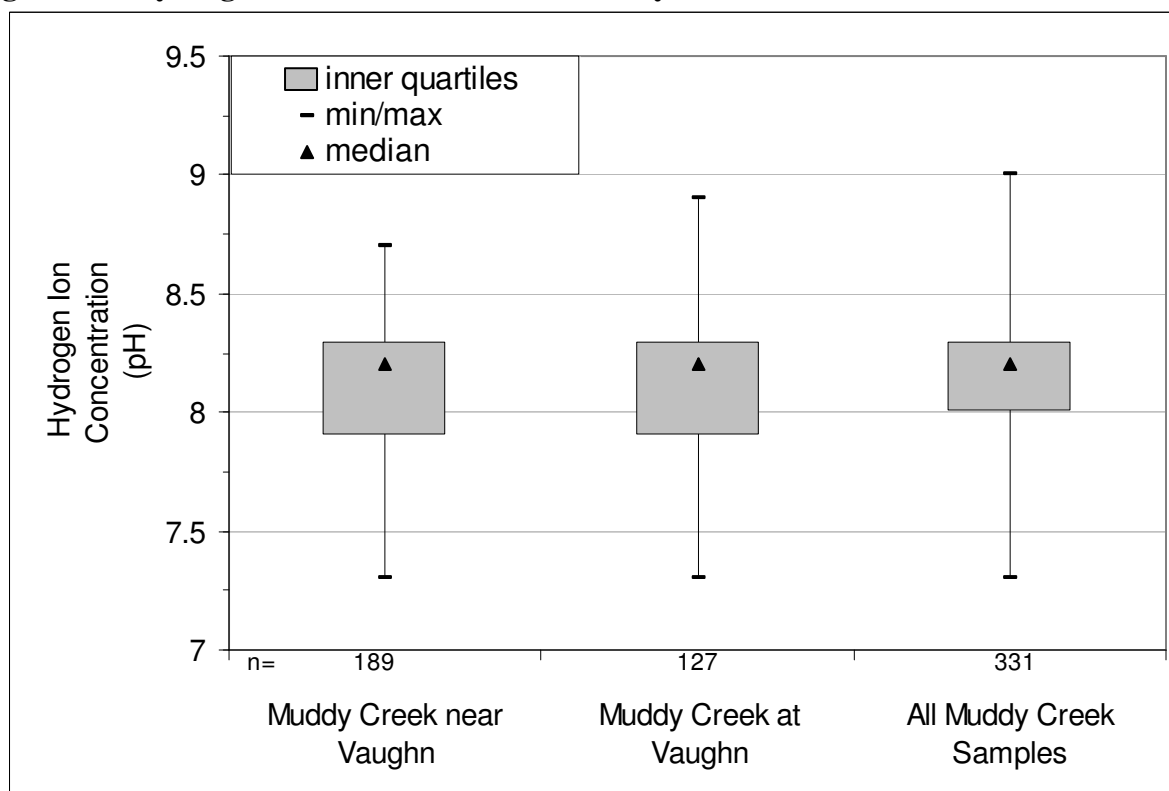
Figure 5-1. Hydrogen Ion Concentration in Muddy Creek at USGS Stations.

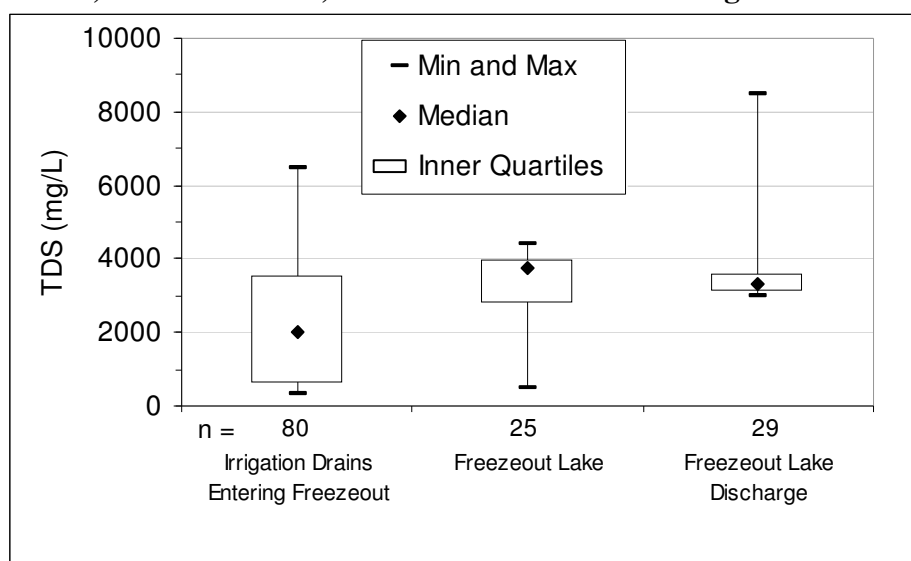
Figure 6-1. Total Dissolved Solid Concentrations in Surface Water Irrigation Return Flow to Freezeout Lake, Freezeout Lake, and Freezeout Lake Discharge.

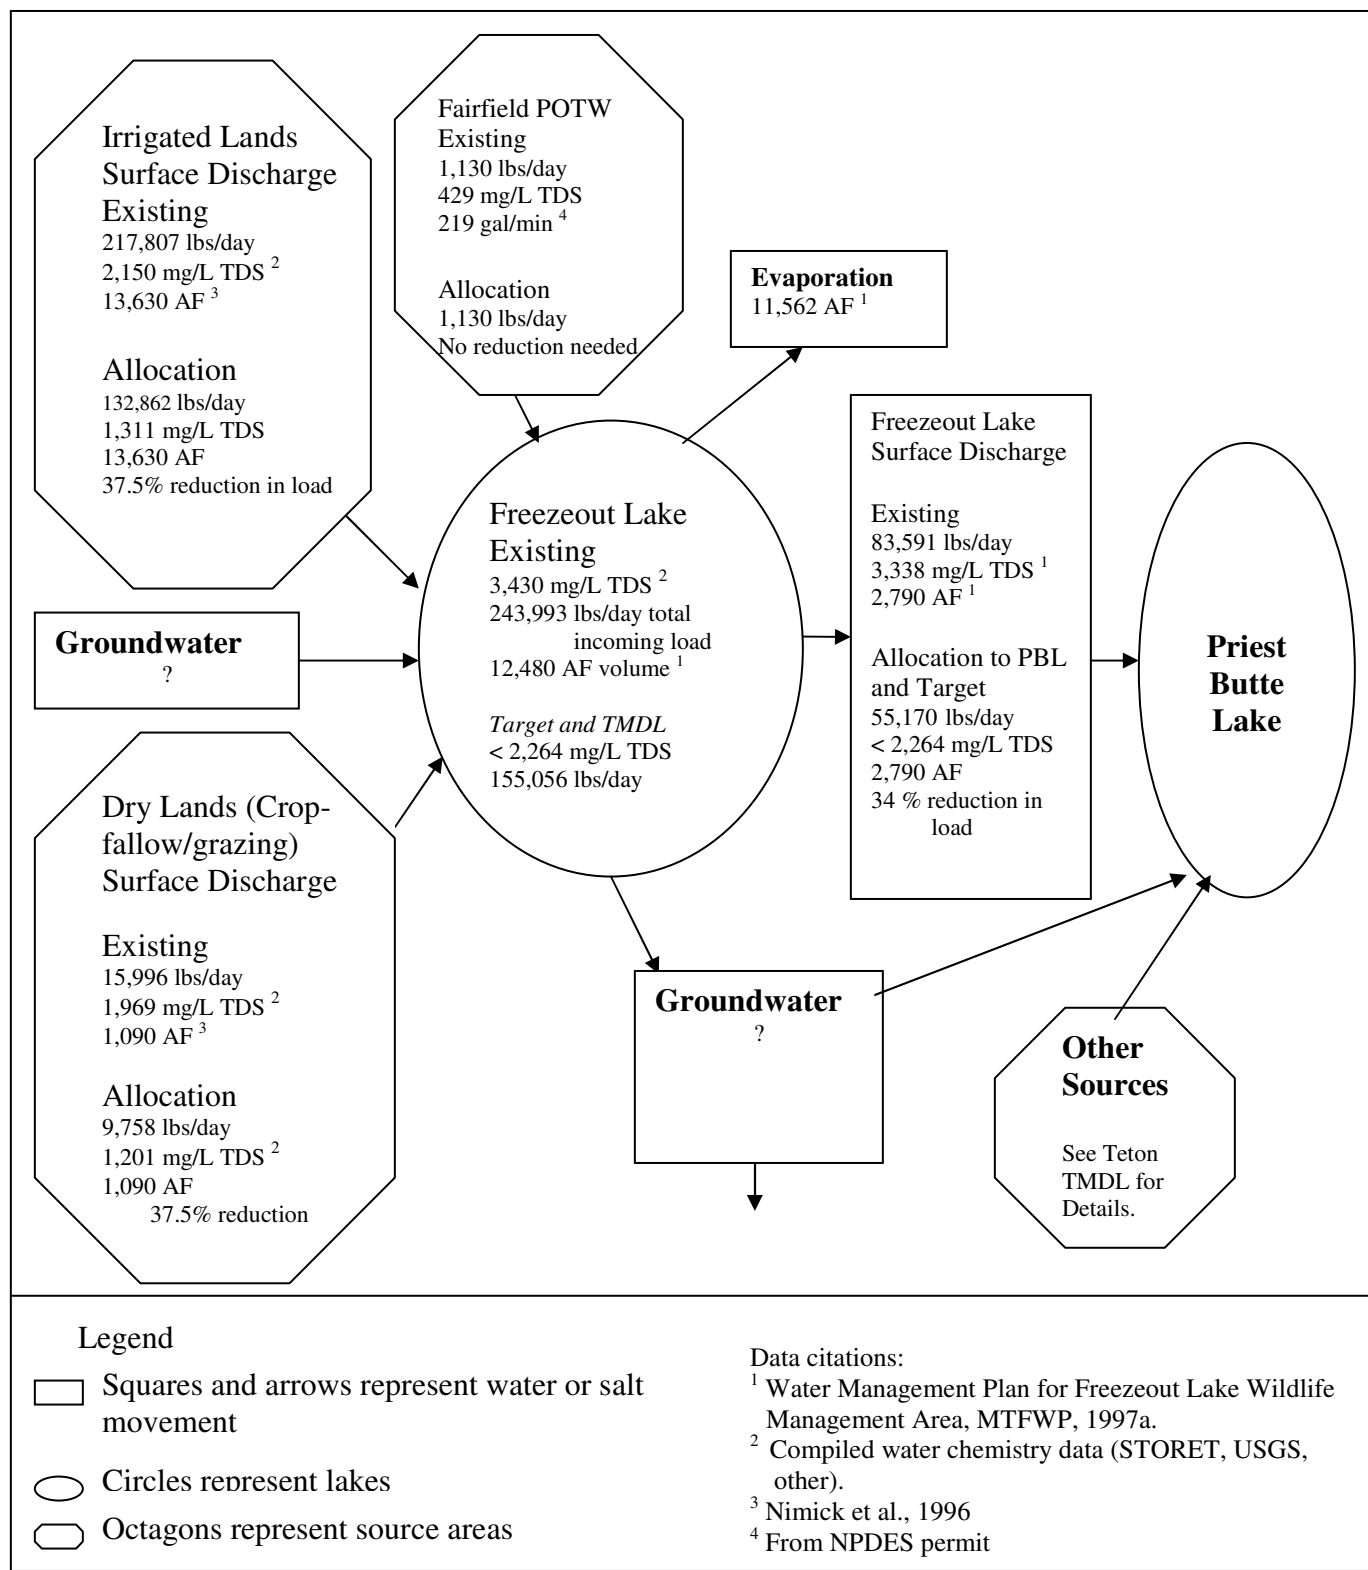
Figure 6-2. Estimated Existing TDS Loading, Targets, Allocation, and TMDL for Freezeout Lake.

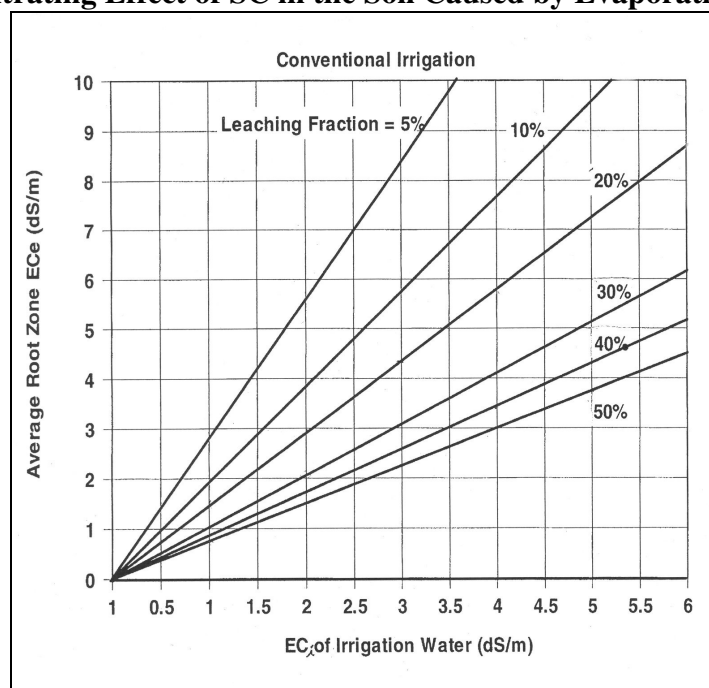
Figure 6-3. Concentrating Effect of SC in the Soil Caused by Evaporation and Plant Use.

The diluting effect of precipitation must also be considered in order to correctly calculate SC values for irrigation water that will protect irrigated plants. If more rainfall is flushing through the soils, then higher salt content of irrigation water can be used without negatively affecting the soils and crops. The average annual total precipitation in Muddy Creek and lower Sun River areas is about 12 inches (Prism Precipitation Model, Map 2-1). Field corn is grown during various years in the eastern portion of the Sun River watershed, and is the most sensitive field crop in the Sun River watershed. Field corn requires about 30 inches of water for proper growth plus the 15 percent leaching fraction (34.5 inches total). The diluting effect of this precipitation is dependent on the amount of irrigation water that is applied. According to DeMooy and Franklin (1977), the effective infiltration of precipitation in the region is about 80 percent. That is, some of the precipitation simply runs overland to the nearest drainage without soaking into the soil. This is especially true during thunderstorms, which are common in the region. Therefore, an effective precipitation of 9.6 inches ($0.8 \times 12 = 9.6$) is a reasonable value for calculating the infiltrating rainfall correction factor. The rainfall correction factor for the area is 1.4.

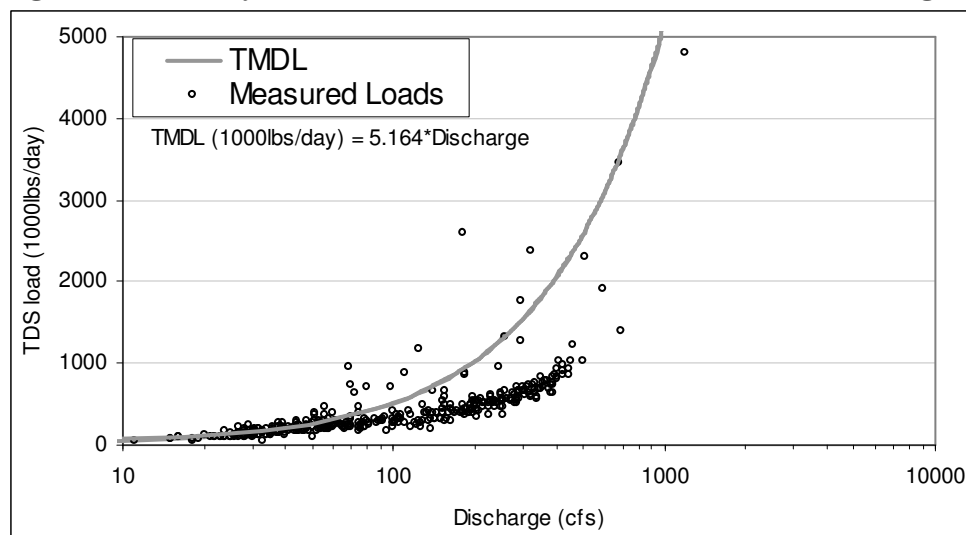
Figure 6-8. Muddy Creek TDS TMDL and Measured Loads at Vaughn.

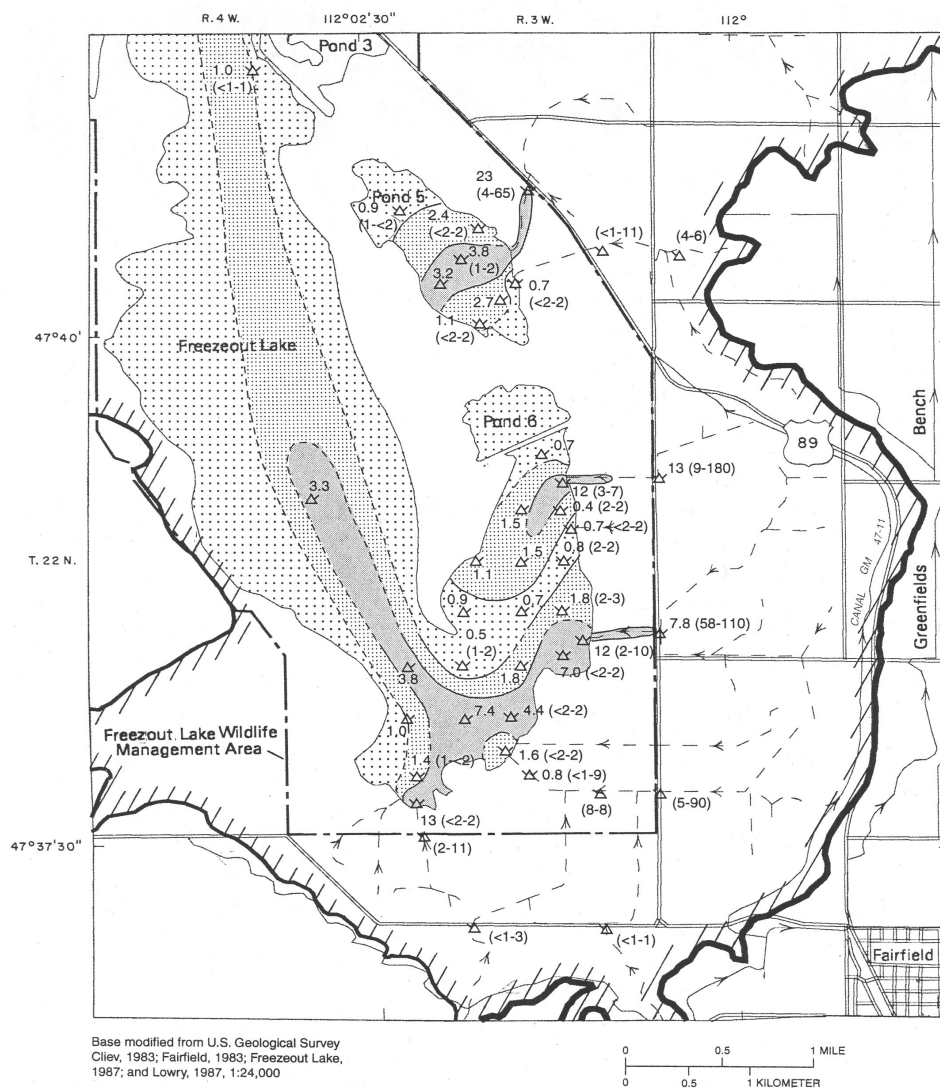
Figure 7-2. Selenium Concentrations in Surficial Bottom Sediment in August 1995 and Ranges in Surface Water Concentrations from 1990-1995.

CONCENTRATION OF SELENIUM IN BOTTOM SEDIMENT, IN MICROGRAMS PER GRAM--Lines of equal concentration are dashed where approximately located

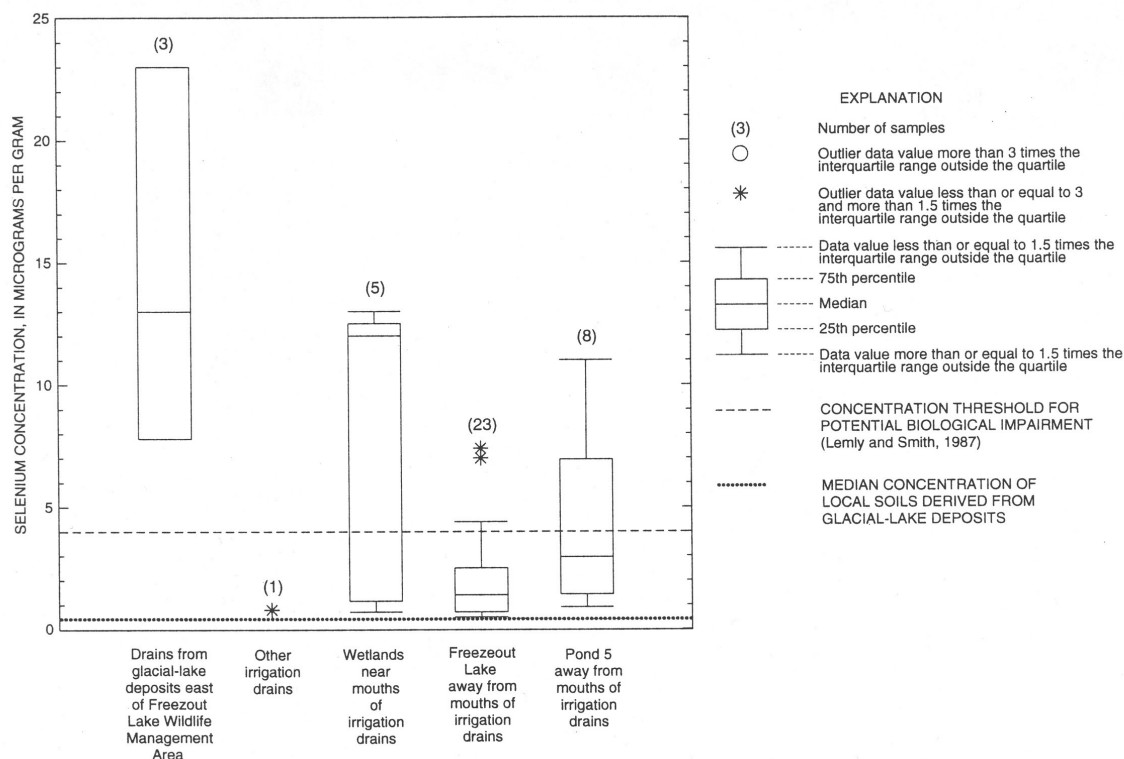
Figure 7-3. Distribution of Selenium Concentration in Surficial Bottom Sediment from the Southern Freezeout Lake Area.

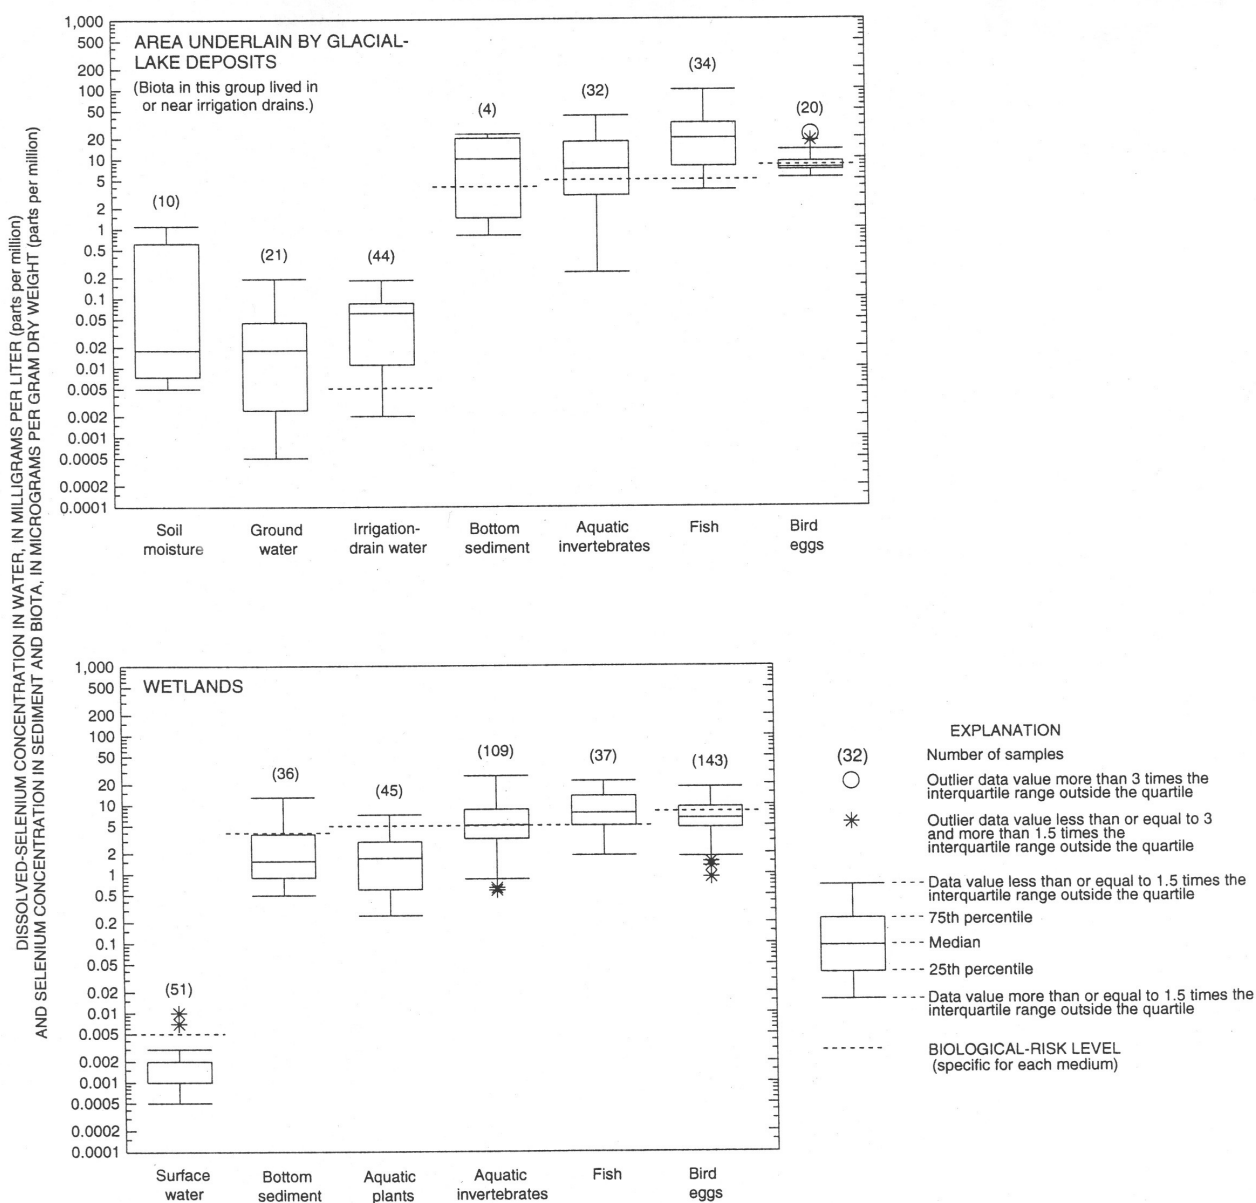
Figure 7-5. Distribution of Dissolved Selenium Concentrations in Water, Bottom Sediment, and Biological Samples from Southern Freezeout Lake Area.

(from Kendy et al., 1999) Half detection limits used if sample was reported below a detection limit. Biological risk levels refer to total-recoverable selenium and are the same outlined for Figure 7-4.

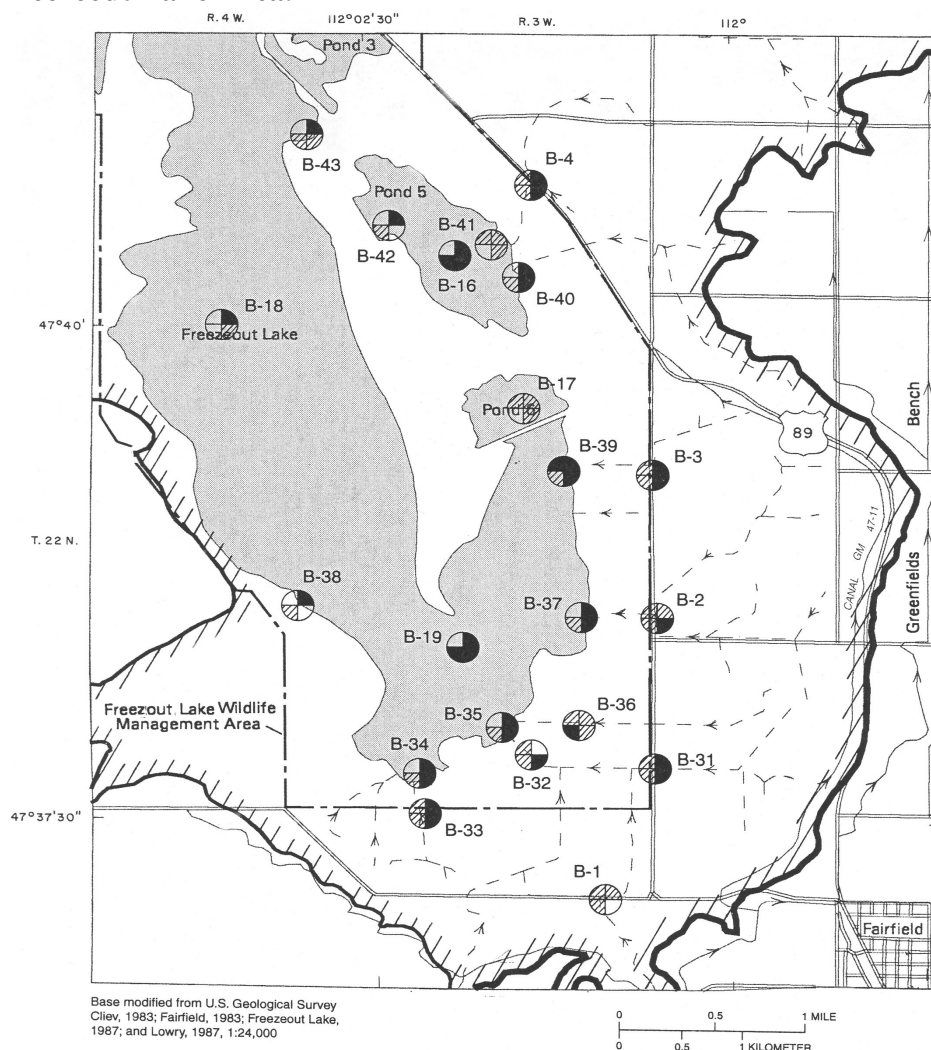
Figure 7-6. Biological Sampling Sites where Geometric Mean Selenium Concentration in at Least One Species Exceeded the Concentration Threshold for Biological Impairment in the Southern Freezeout Lake Area.

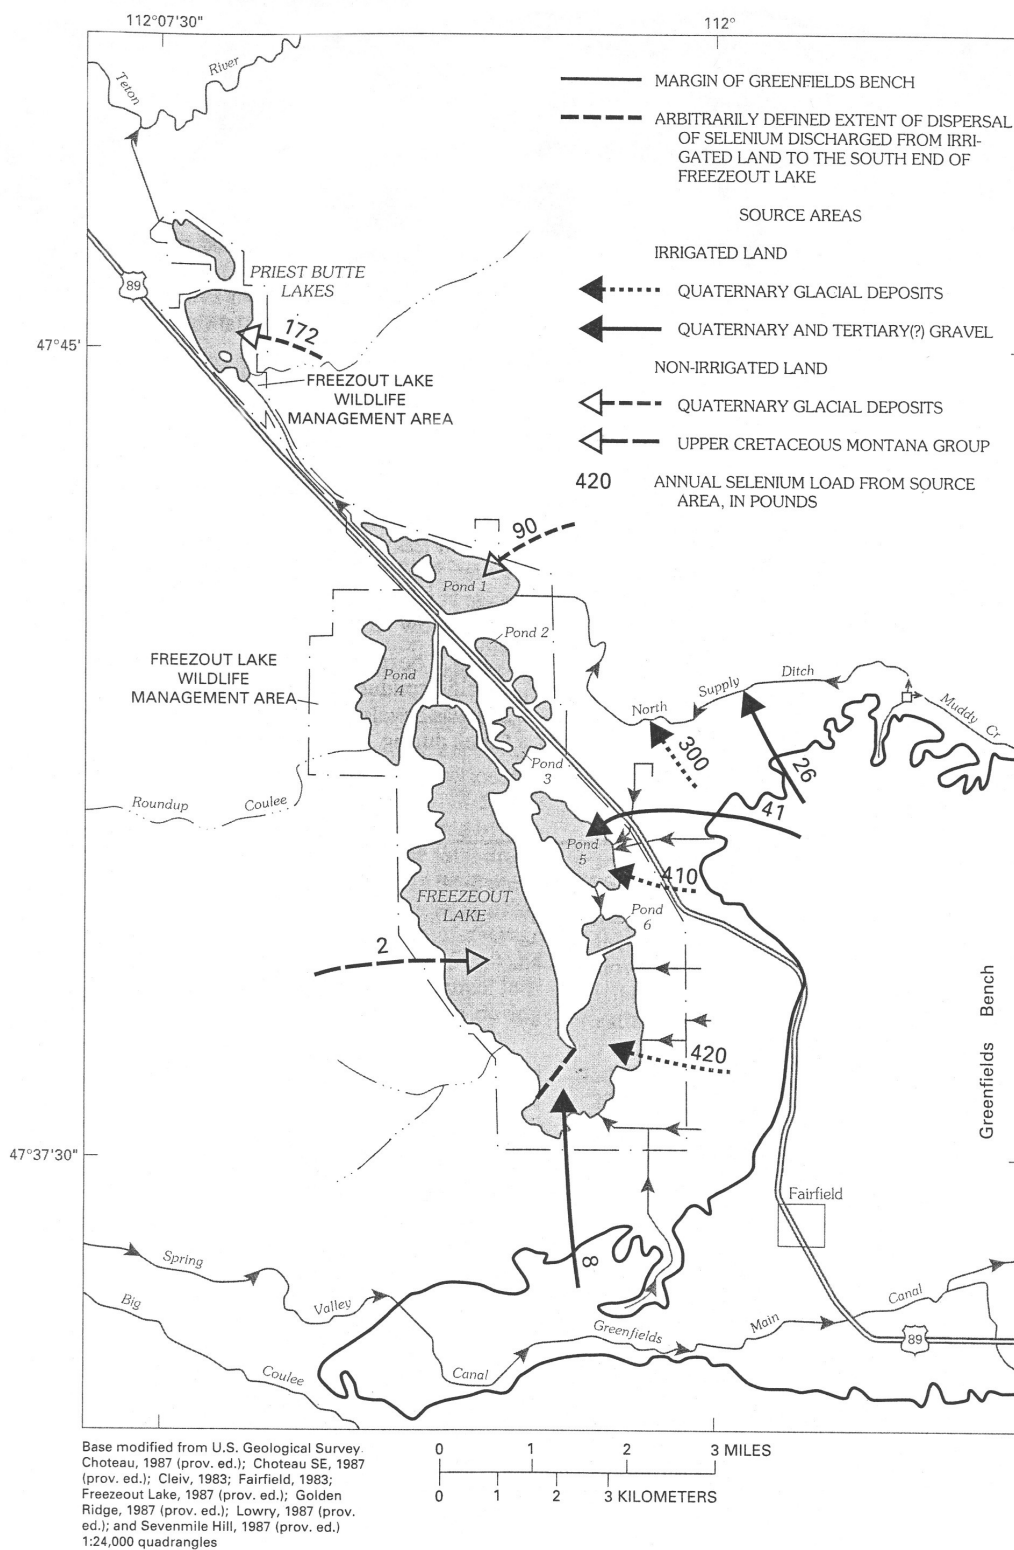
Figure 7-8. Spatial Representation of Estimated Average Annual Selenium Load Discharge to Freezeout Lake WMA.

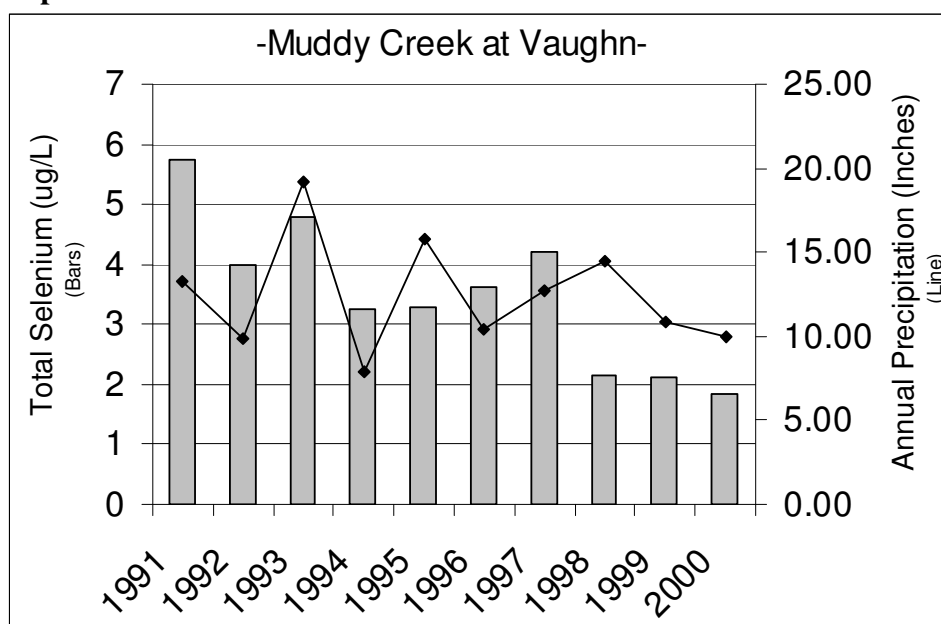
Figure 7-10. Average Annual Selenium Concentrations in Muddy Creek and Average Annual Precipitation.

Precipitation is an average of Fairfield and Power data.

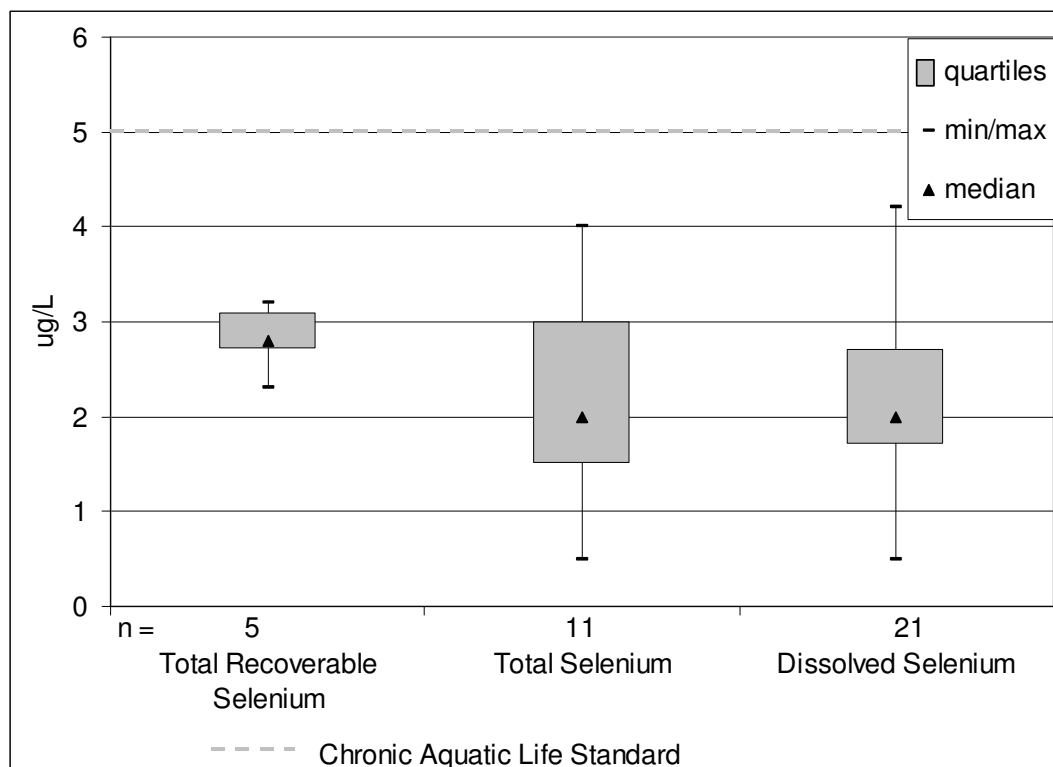
Figure 7-13. Average and Maximum Selenium Concentrations in Water Draining from the East and South Portions of the Greenfields Bench.

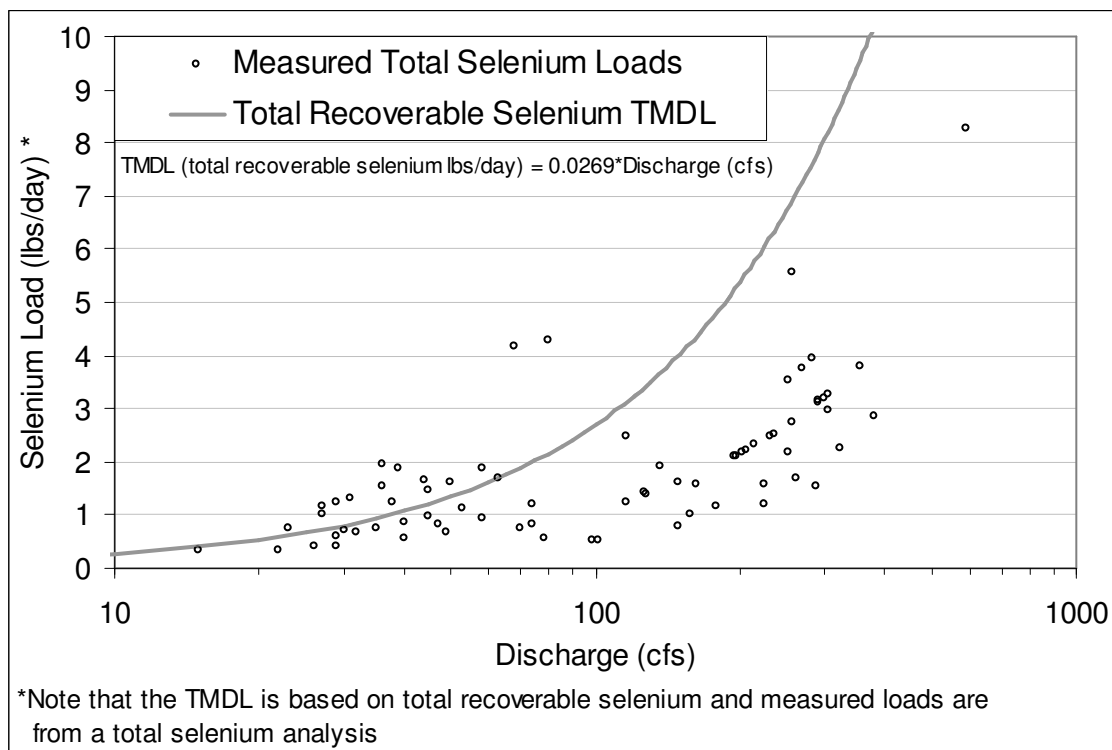
Figure 7-15. Muddy Creek Selenium TMDL and Measured Loads from 1991-2000.

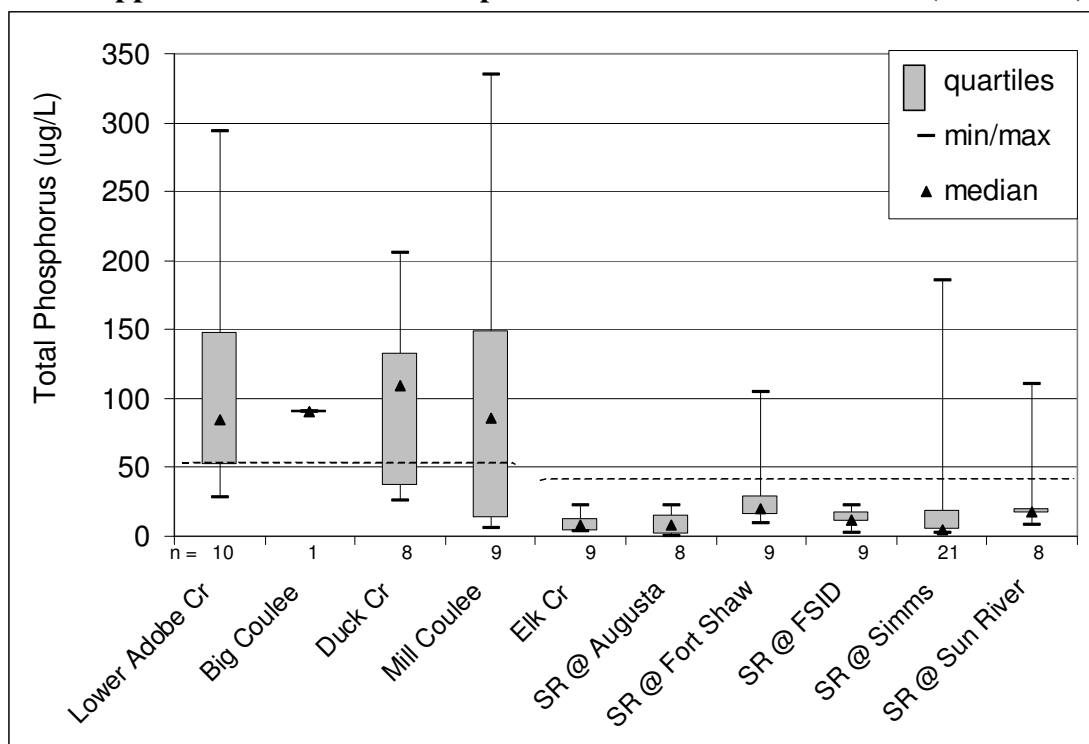
Figure 8-1. Upper Sun River Total Phosphorus Summer Concentrations (1996-2003).

-The total nitrogen target for the upper Sun River is indicated as a dashed line.
 -Nutrient criteria for tributaries are also included as dashed lines.

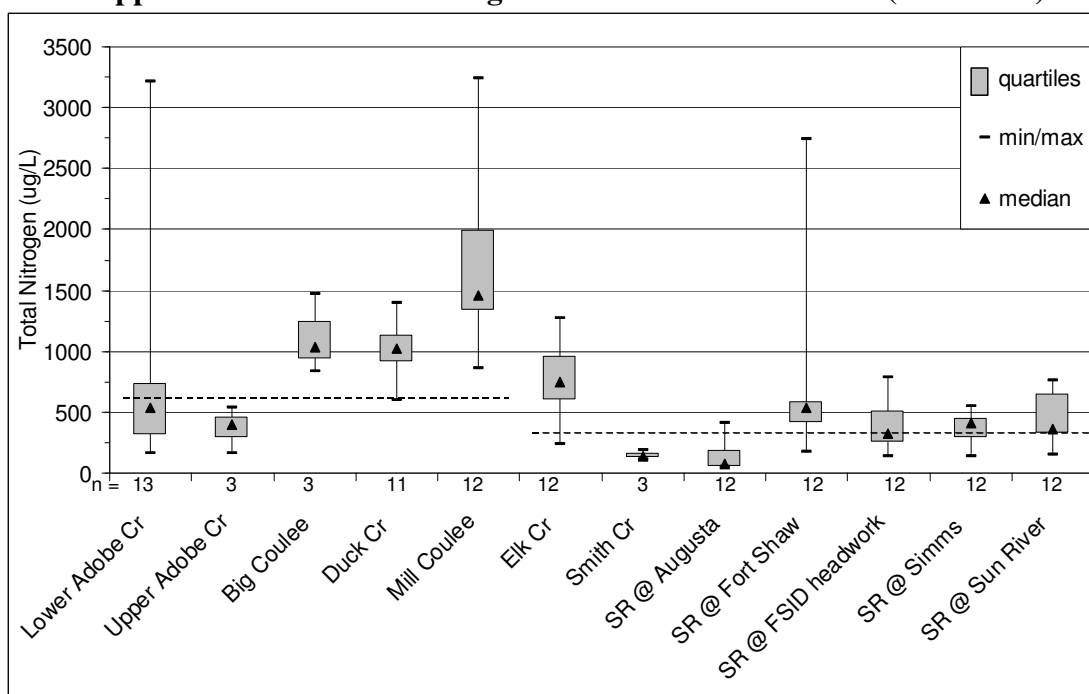
Figure 8-2. Upper Sun River Total Nitrogen Summer Concentrations (1996-2003).

-The total nitrogen target for the upper Sun River is indicated as a dashed line.
 -Nutrient criteria for tributaries are also included as dashed lines.
 SR = Sun River, FSID = Fort Shaw Irrigation District

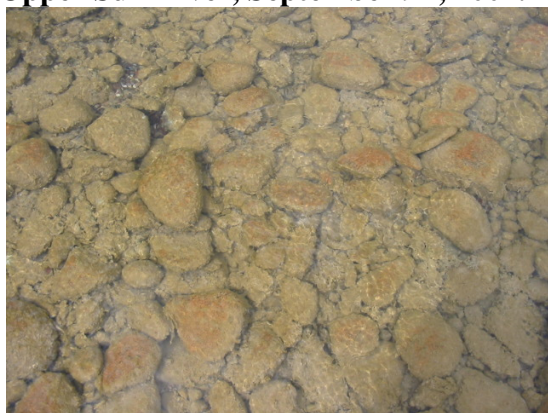
Figure 8-3. Pictures of Algae Growth on the Stream Bottom in Shallow Glide Areas of the Upper Sun River, September 9th, 2004.

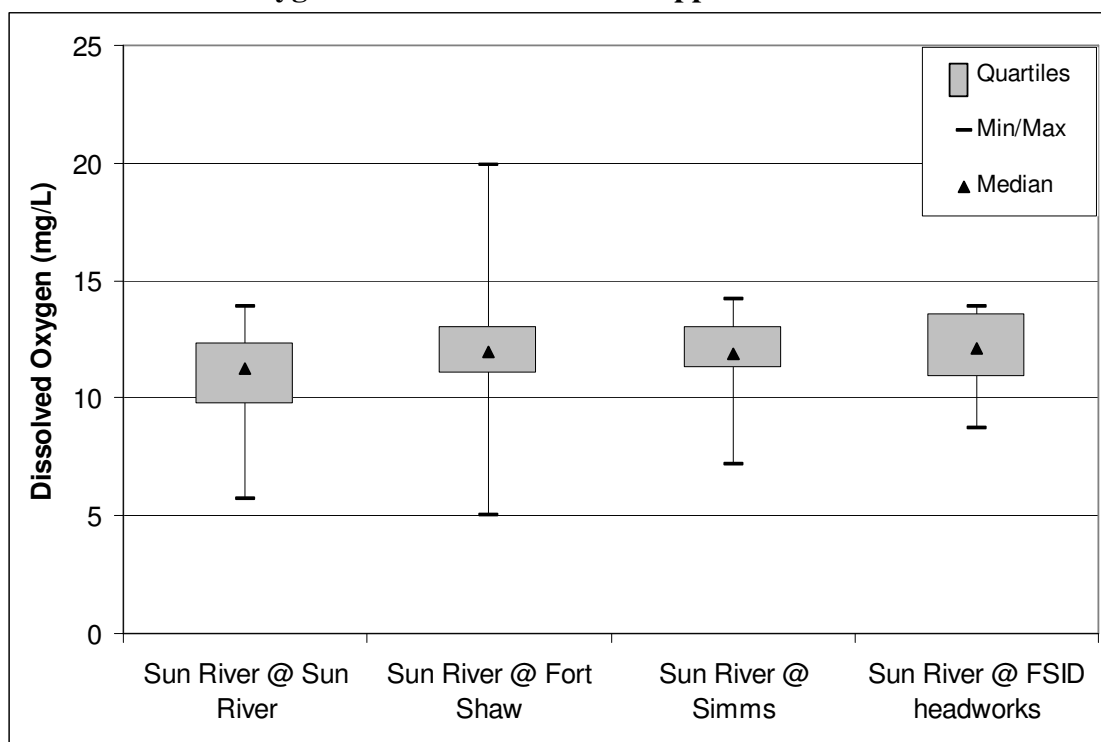
Figure 8-4. Dissolved Oxygen Concentrations in the Upper Sun River 2001-2003.

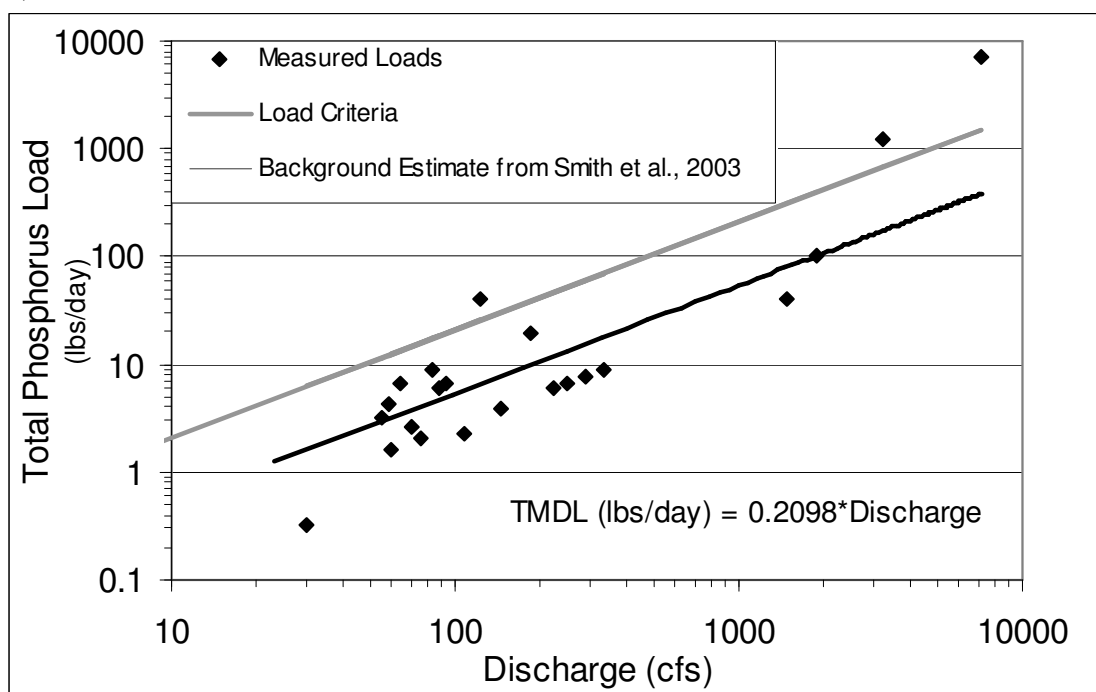
Figure 8-6. Upper Sun River Total phosphorus Load Criteria, Estimated Background Loads, and Measured Loads at Simms.

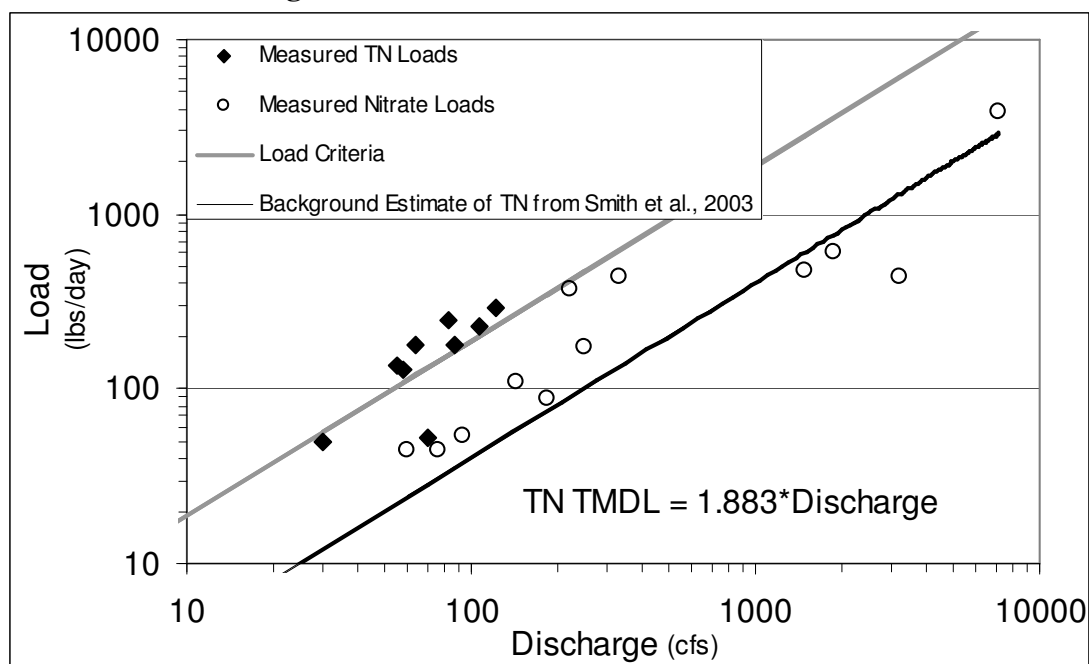
Figure 8-7. Upper Sun River Total Nitrogen Load Criteria, Estimated Background Loads and Measured Total Nitrogen and Nitrate Loads at Simms.

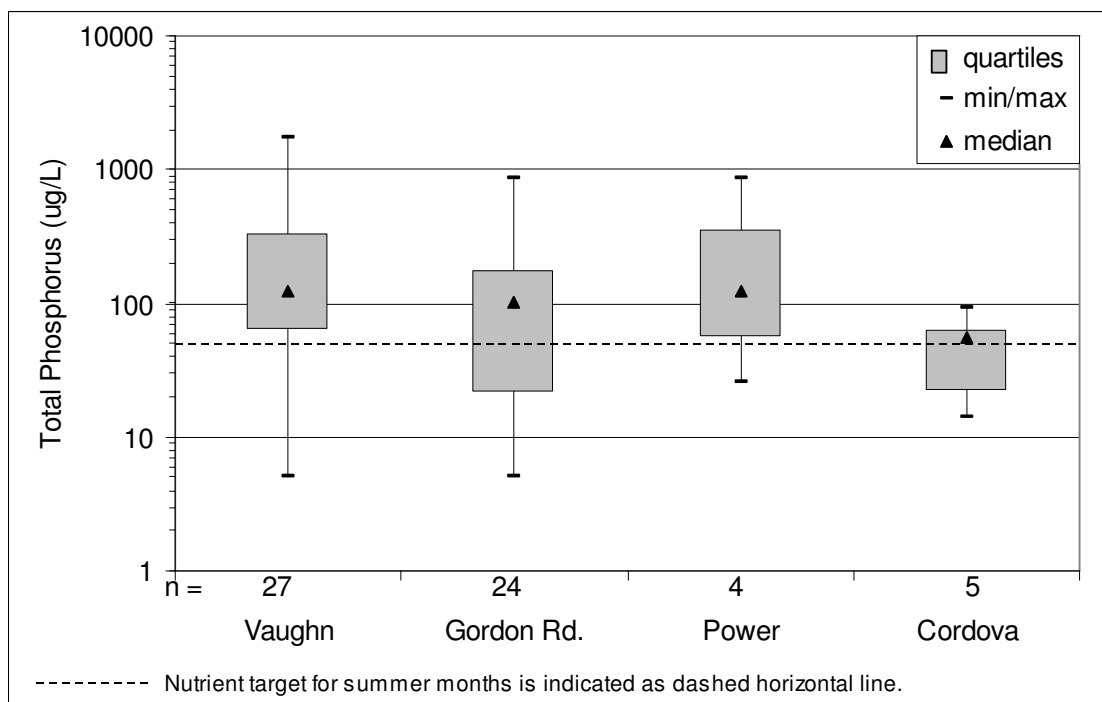
Figure 8-8. Muddy Creek Total Phosphorus Summer Concentrations (1996-2003).
